Safety Inspection Report

Annual Inspection

Langley Street Playing Field

17 June 2019

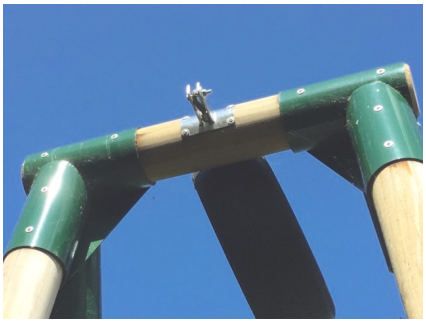
Cableway

The supporting components should be dismantled and inspected according to the manufacturer's instructions. This will need doing on a regular basis.

Risk level:

Medium

Risk score:

8

Dismantle and inspect according to manufacturer's instructions.

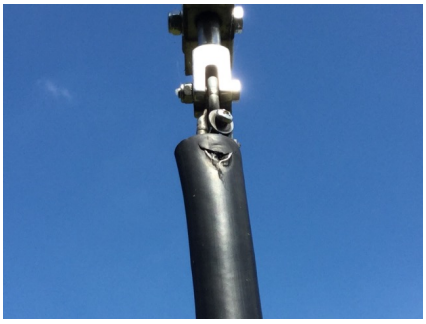
Item is damaged.

The rubber sleeve bolt has ripped through the rubber, allowing it to slip down the chain - re-install the top bolt 4-5” from the top of the runner sleeve.

Risk level:

Low

Risk score:

5

Read the notes for further action.
